### What can the V8 badging reveal?

Factory MGBGT V8s had three silver coloured "V8" badges to identify the model – one on the grille, one of the nearside wing next to a square "BL" badge and one on the nearside bottom edge of the tailgate. With the introduction of the rubber bumper model in the second half of 1974 and the loss of the classic grille and grille mesh, there was no longer a V8 badge at the front of the car.

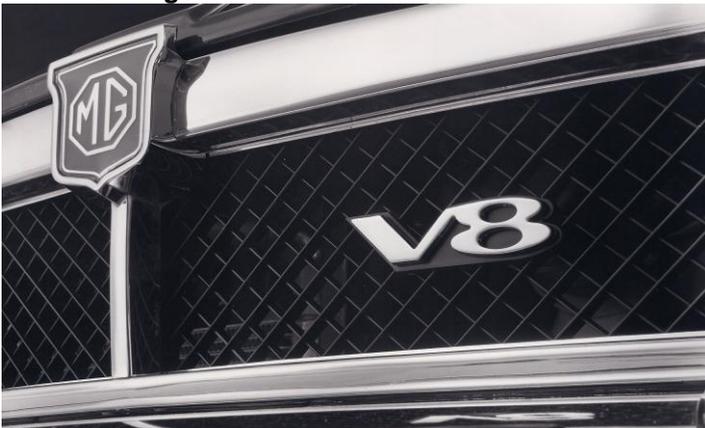
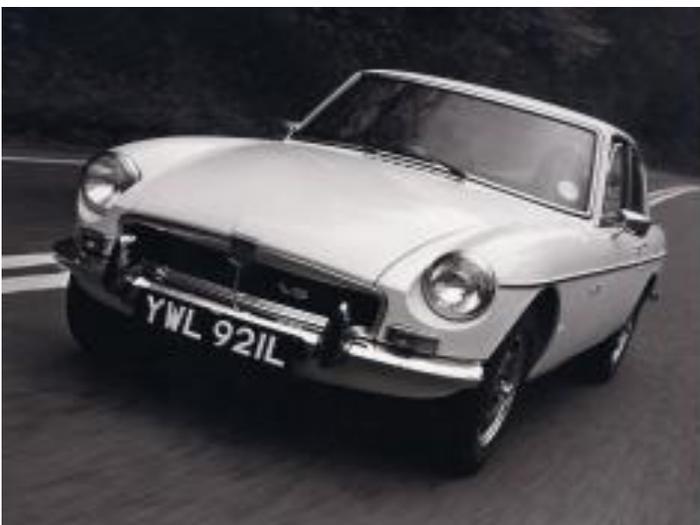
#### Front V8 badge

BL publicity photos at the time of the launch of the MGBGT V8 in August 1973 show the location of the V8 badge on the nearside of the front grille mesh very well. The rubber bumpered model did not have a V8 badge at the front because the large rubber bumpers replaced the grille surround and mesh.

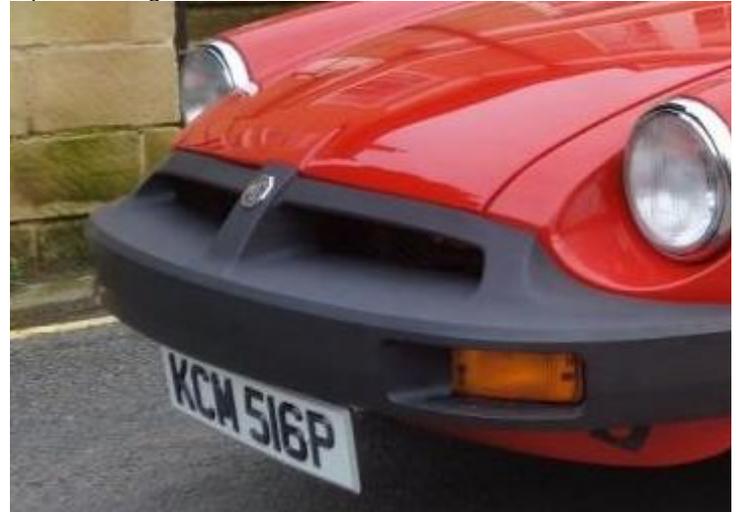
Some owners have fitted a V8 badge on a bracket attached to the mesh screen behind the rubber bumper so the badge is visible in the nearside opening of the rubber bumper. The first Factory rubber bumper MGBGT V8, Teal Blue 2101 formerly owned by the late Geoff Allen, had this neat but non standard modification.

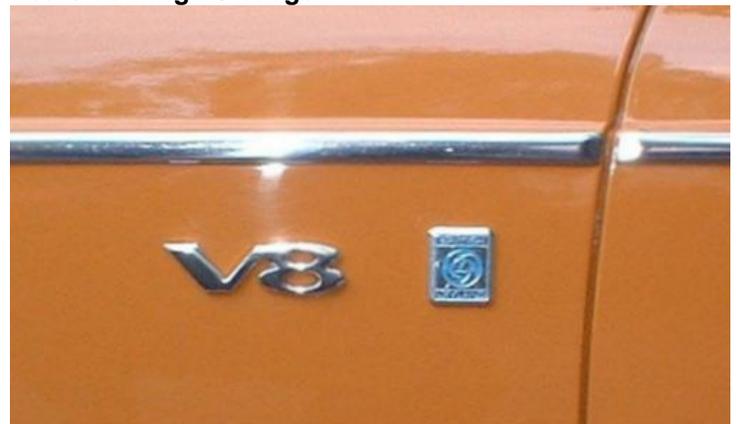
The nearside wing V8 badge was on both chrome and rubber bumpered Factory produced MGBGTV8s. The positioning of the badge is set out in [V8NOTE253](#) in Volume 7 of the V8 Workshop Notes series.

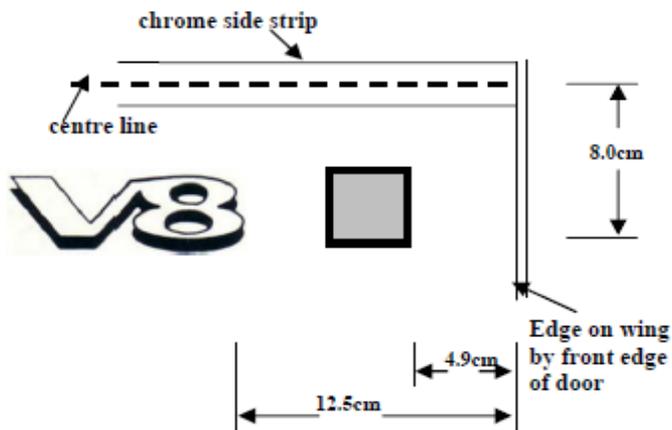
**View of nearside wing between the rear of wheel arch and front edge of the door**

There was **no badge on the offside wing** of Factory produced MGBGTV8s. Frequently you see restored V8s with badges on the offside wing.

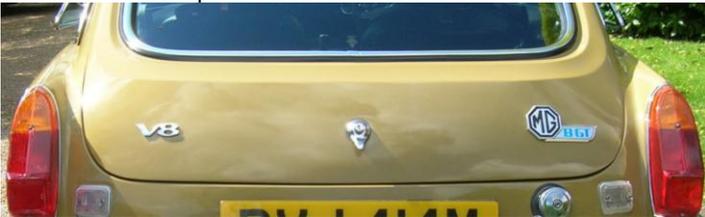
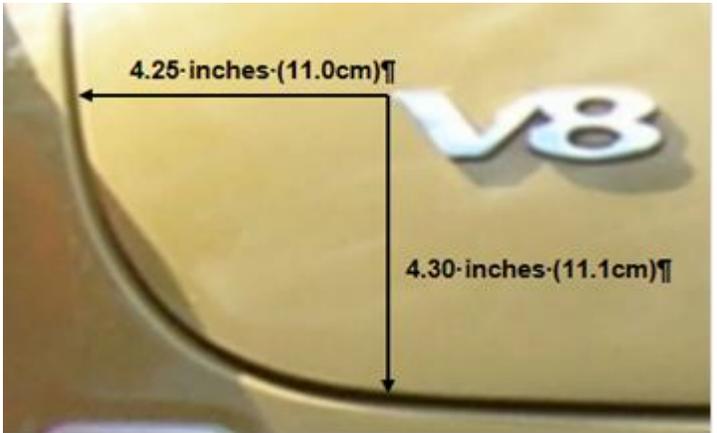
### Tailgate V8 badge

It's located near the bottom edge of the tailgate on the nearside on both chrome and rubber bumpered Factory produced MGBGTV8s. The positioning of the badge is set out in [V8NOTE253](#) in Volume 7 of the V8 Workshop Notes series.

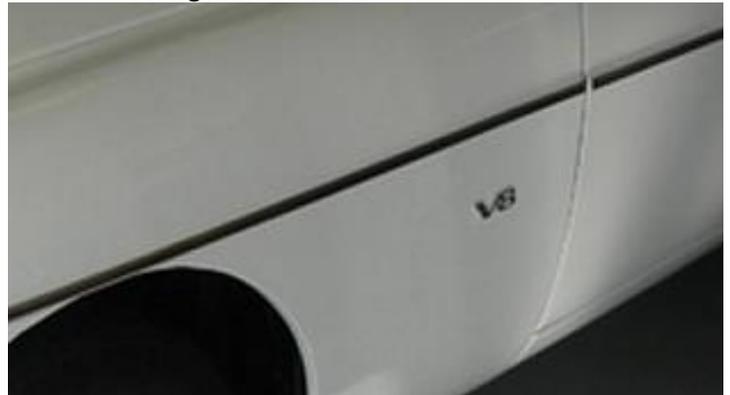
**V8 badge on the nearside wing but far too low** and the square BL badge is missing too. In some cases back in the late 1970s owners of MGs were so disgusted with how BL had closed the MG Factory in Abingdon that they removed the BL badge as a protest!

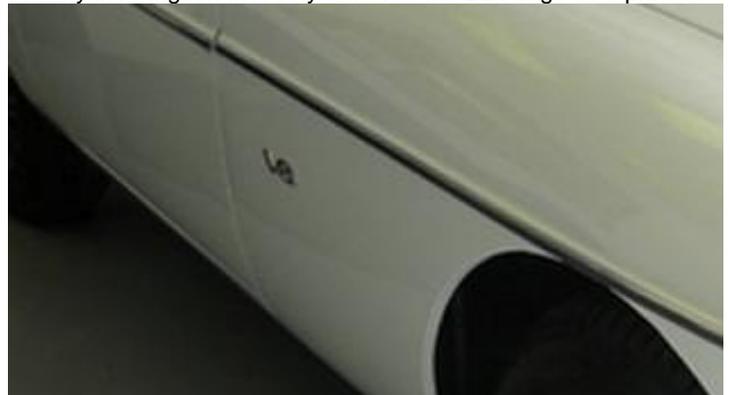
The restorer also located a **V8 badge on the offside wing**, again in the low position and without a "BL" badge.

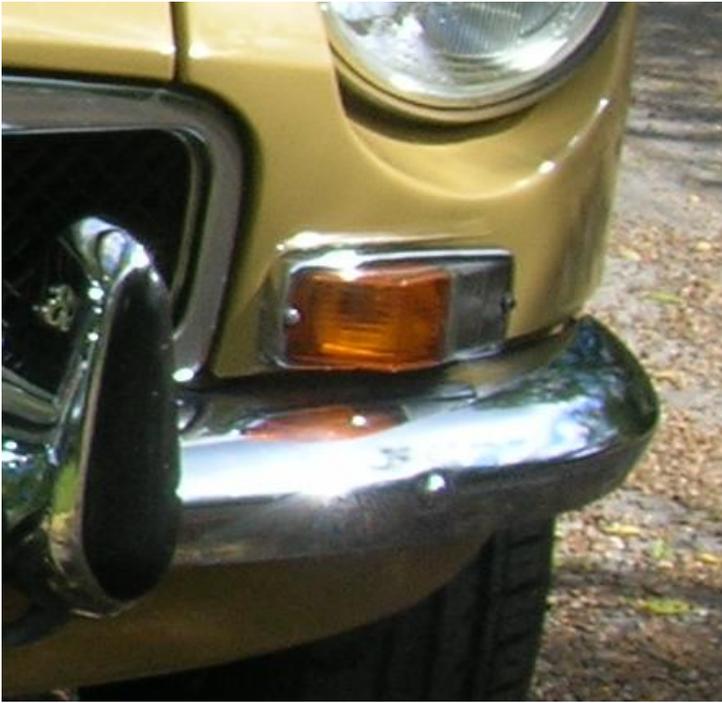
**V8 badges missing**

Often on restored MGBGTV8s badging is missing. Sometimes it is because the owner cannot find replacement badges but they are available but note that whilst the V8 badge for the nearside wing is flat, the badge for the tailgate is curved in both directions - sideways and top to bottom – to fit the rounded contours of the tailgate. The V8 badge for the grille mesh of the chrome bumper V8 is mounted on a backing bolted through the plastic mesh.

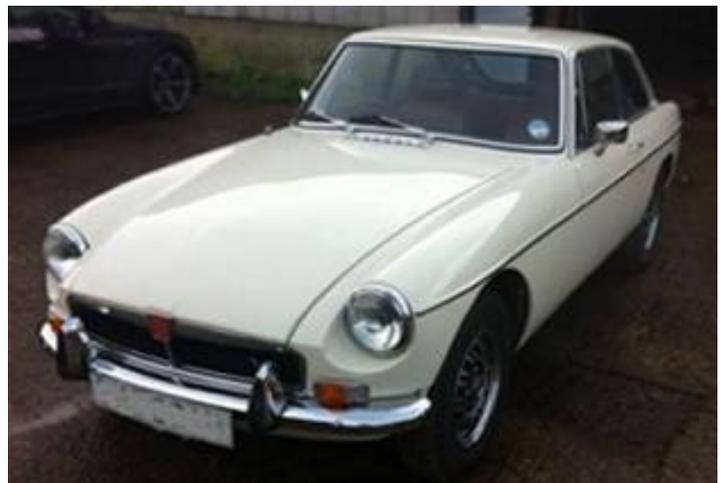
**Make sure you have the right grille mesh!**

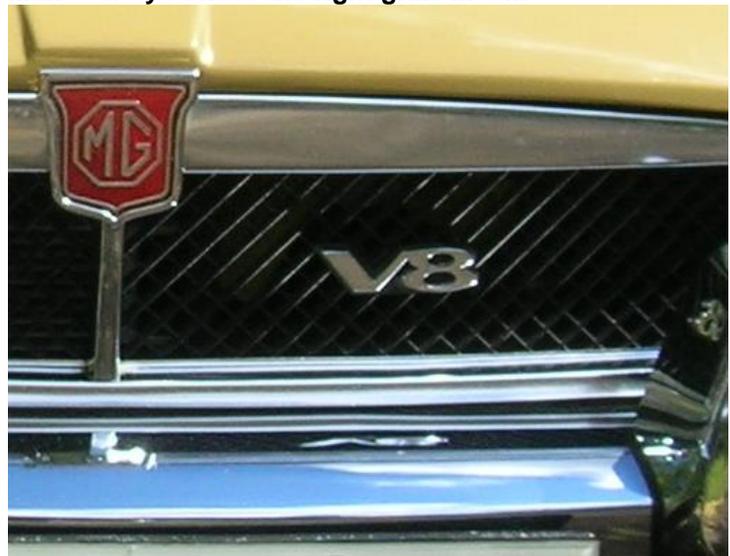
An original grille mesh fitted to a chrome bumper MGBGTV8.

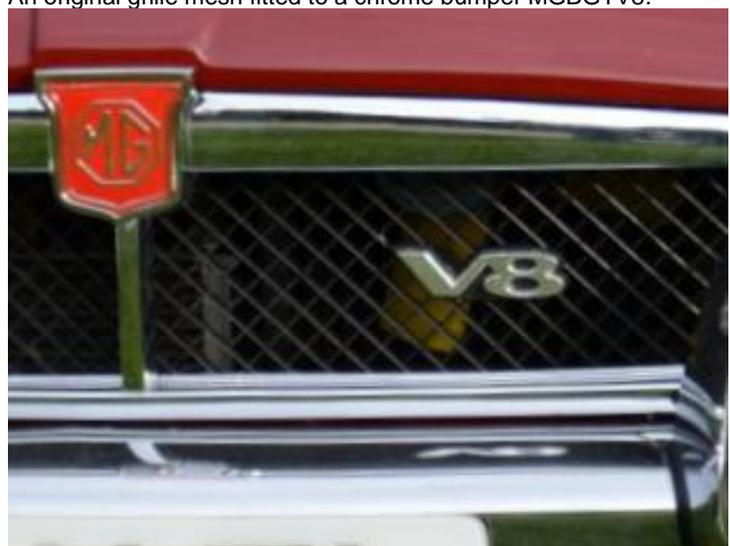
Reproduction grille mesh from the 1990s - you can see the bold feature on the mesh panel is reversed.
